An RFI Story with a Happy Ending

One ham's tale about keeping RF from where it doesn't belong.

Richard Kriss, AA5VU

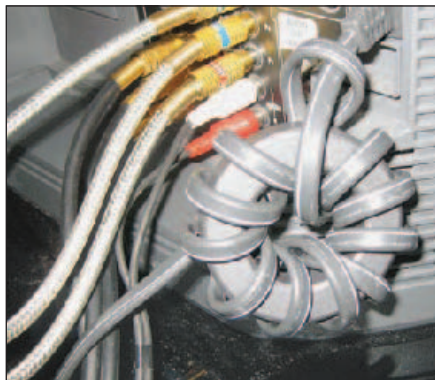
Figure 2 — A common mode choke on the power line, right at the receiver, attenuates RF on that path.

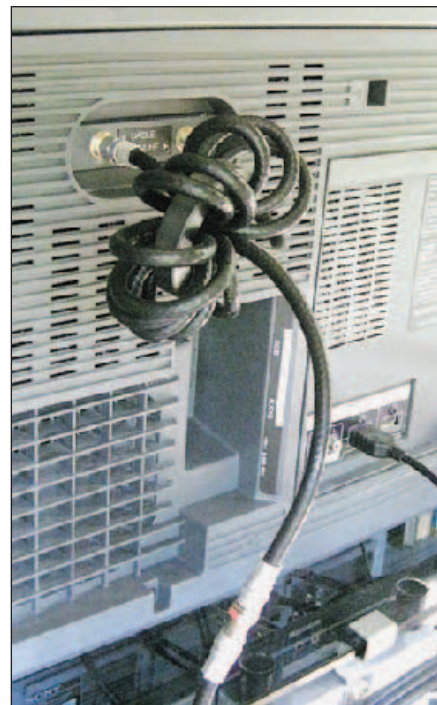
Figure 3 — The common mode choke installed on the coax input to the TV. This helped, but wasn't the final answer.

The first step was to isolate how the interference was getting into the TV. As recommended, all cables, with the exception of the power cord and the TV coax, were removed. The flashing menu was still present when I transmitted with high power. Mike suggested the use of a common mode choke using an FT-240-43 ferrite core on the power line, based on a detailed article by ARRL Lab Manager Ed Hare, W1RFI.¹ This helped, but did not solve the problem. Another common mode choke was made up to go on the coax input to the TV. It also helped but did not completely solve the problem.

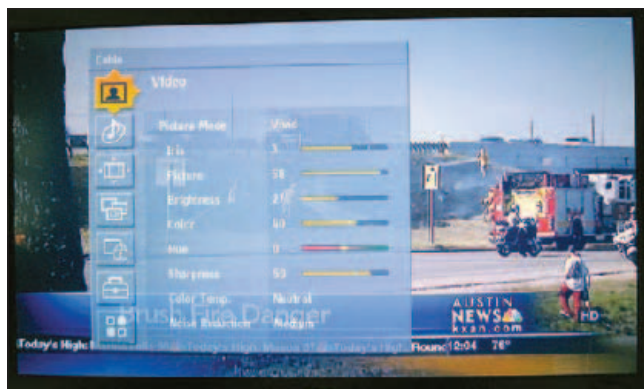
Figure 1 — The dreaded flashing menu flavor of TVI.

I contacted the "Doctor" at *QST* for help so that I could run my 800 W station without TVI. When I started, anything over 100 W would interfere with the TV's remote control receiver circuits and cause the on-screen menu panel to flash on and off. Thanks to help from the "Doctor" and ARRL Lab RFI Engineer Mike Gruber, W1MG, the problem has been solved. This article describes the steps taken to clear the interference.

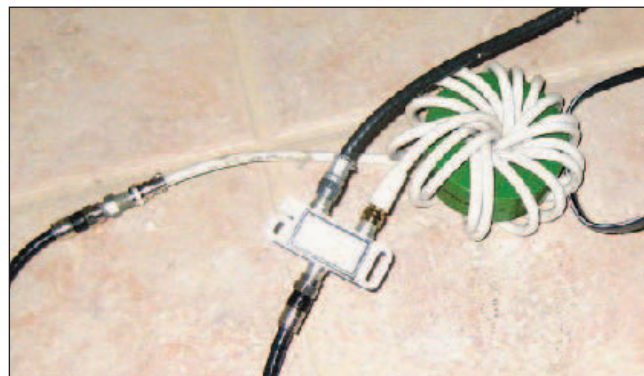
Figure 4 — A common mode choke on the coax cable. Note that an added length of coax was connected with a double female socket to provide a length of the needed turns. **QST**

The final source was a cable TV technician-installed wall wart and signal splitter that powers a cable signal booster via the coax. I went to school on the Mike, W1MG, tip and installed another common mode choke where the powered coax is split to go the TV (Figure 4).
